**QuébecSpec Building Inspection**

010	Inspector	
020	Occupancy	Occupied.
030	Building Description	The building type is a single family home.  With a full basement.  Built on a sloped lot.
035	Present during the Expertise	The owner was present.
040	Estimated Age	This structure is approximately 17 years of age as stated by the owner.
050	Weather Conditions	Cool and cloudy.  Outdoor Temperature: 5 Celsius.  Indoor Temperature: 20 Celsius.
060	Start Time	6:45 PM
070	Stop Time	8:45 AM
080	Comments	QuébecSpec was mandated by the owner to determine the reason or reasons for the significant ice build-up on the roof structure during the winter months.

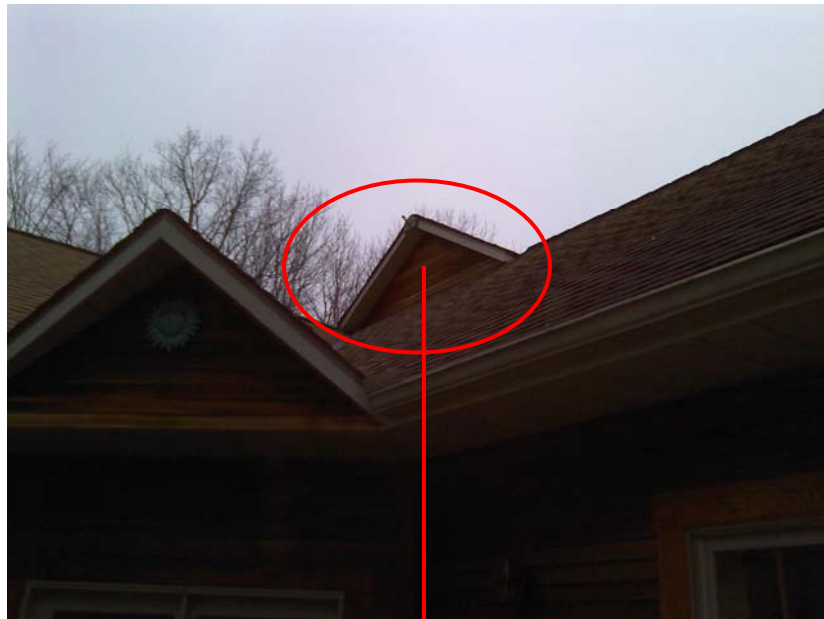
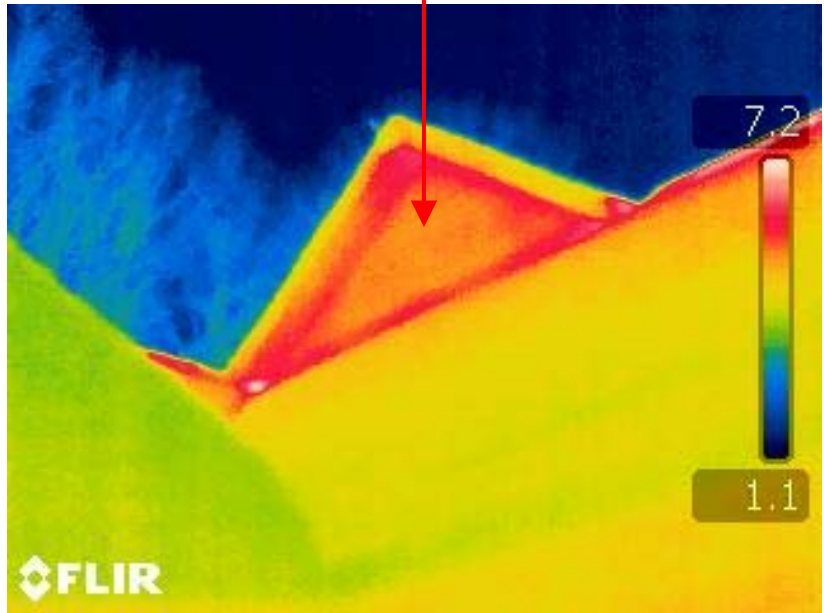
Step #	Component	Comments
301	Roofing Type & Materials	Sloped construction. Asphalt shingles.
306	Roof Comments	<b>Review. Heat loss observed at several areas on the roof.</b>  <b>See comments #357, 360, and 1053.</b>

The yellow to red areas in the picture represent major heat loss and air leakage.

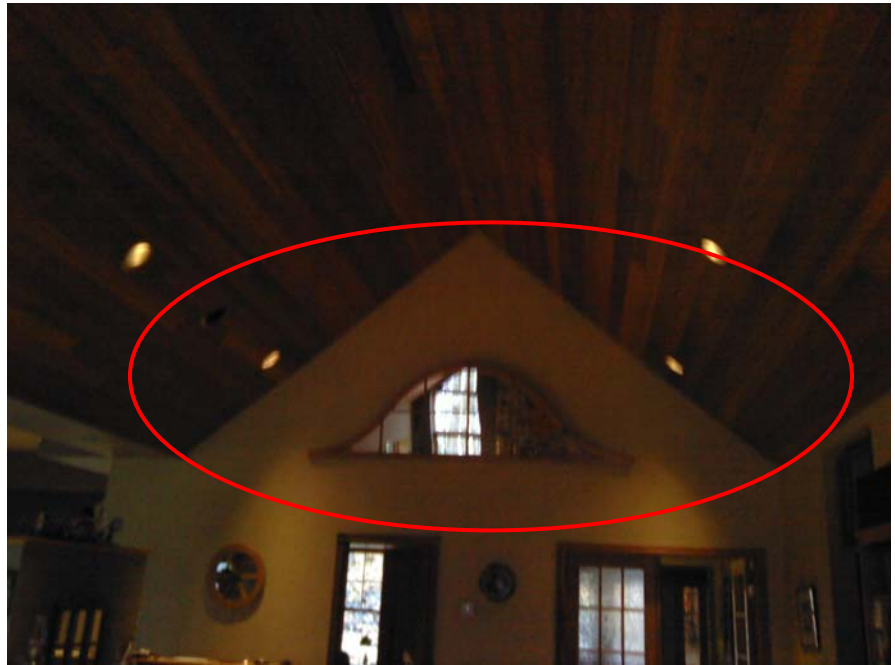
360 Attic Comments **Review. Several areas of heat loss due to air leakage were observed in the attic.**

**Heat loss will cause ice build-up on the roof during the winter months.**

**The major areas of air leakage and heat loss are coming from inside the attic in the above area showed in the picture.**

**We recommend removing the bat insulation from this area and spraying with urethane foam to seal all areas of air leakage.**

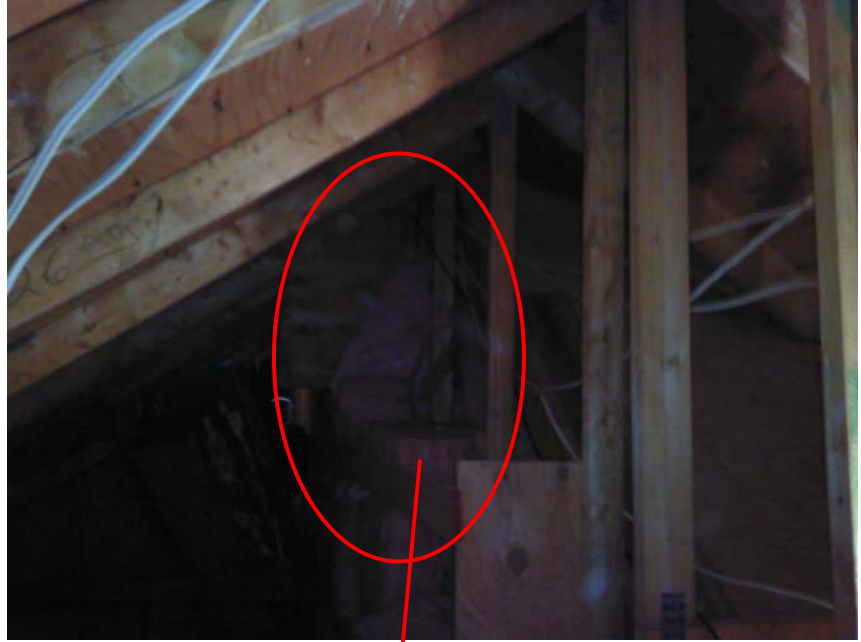
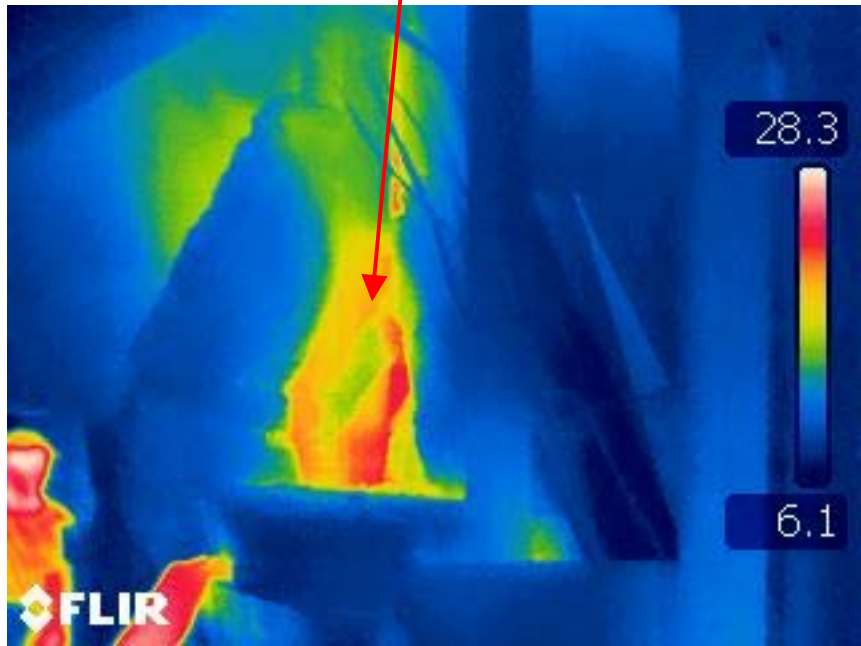
360 Attic Comments

The yellow to red areas in the picture represent major heat loss and air leakage.

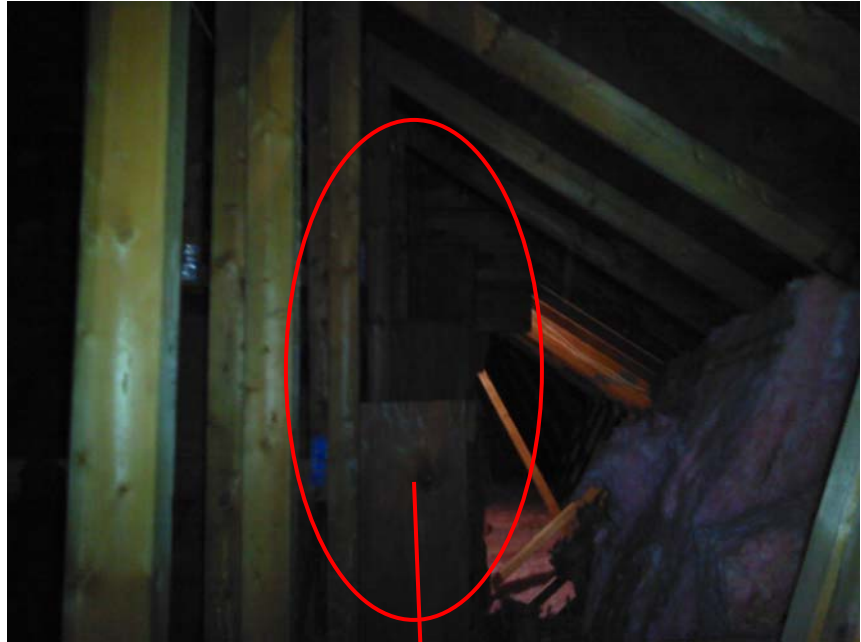
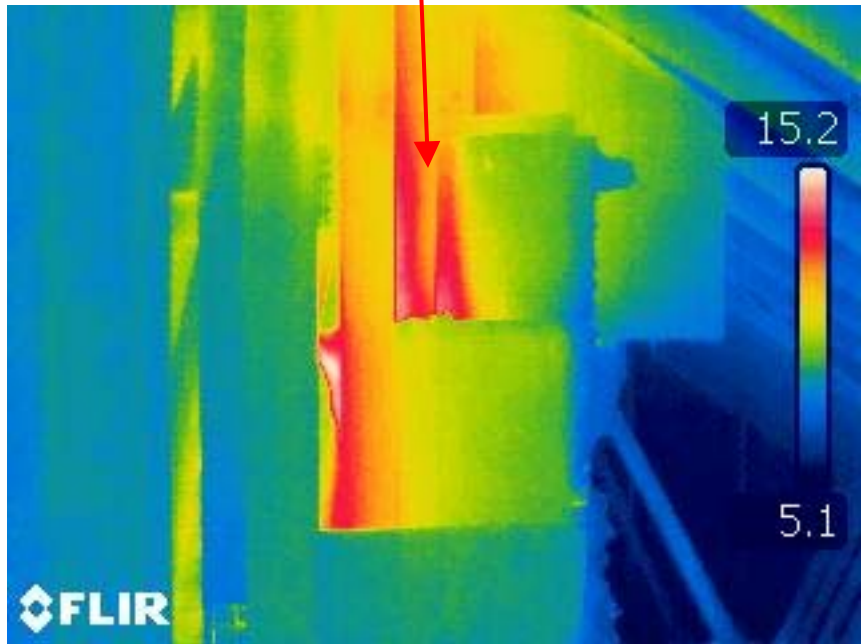
360 Attic Comments

The yellow to red areas in the picture represent major heat loss and air leakage.

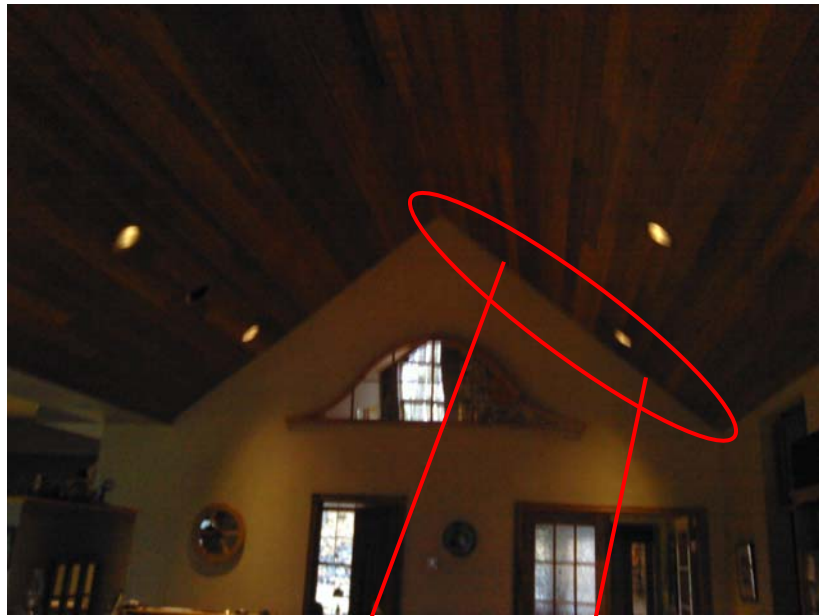
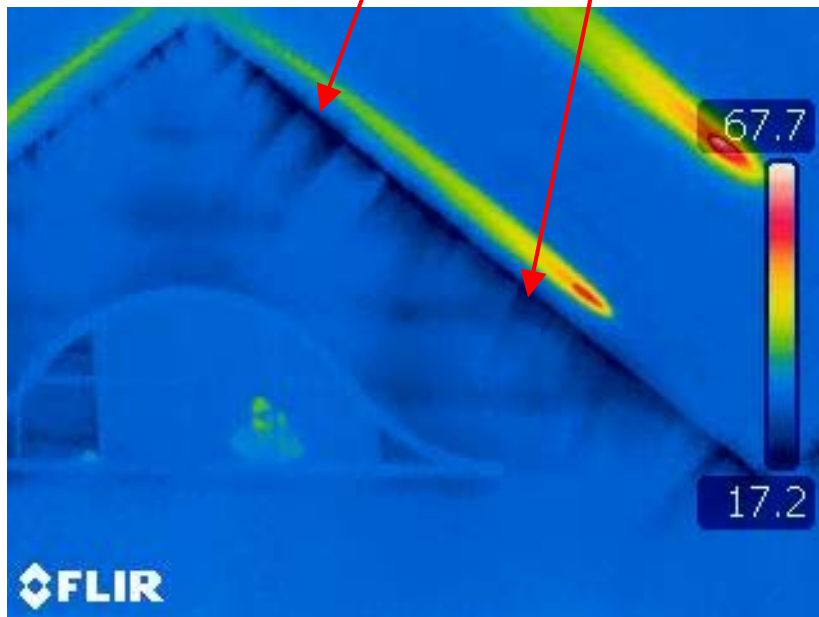
Step #	Component	Comments
1053	Walls / Veiling	<p><b>Review. Air leakage noticed at all wall to ceiling areas.</b></p> <p><b>These areas of air leakage will cause heat to build up in the attic and creating ice problem on the roof during winter months.</b></p> <p><b>We recommend ceiling all of these areas will a flexible caulking to prevent heat loss into the attic.</b></p>

The bleu streaking areas in the picture represent major air leakage.

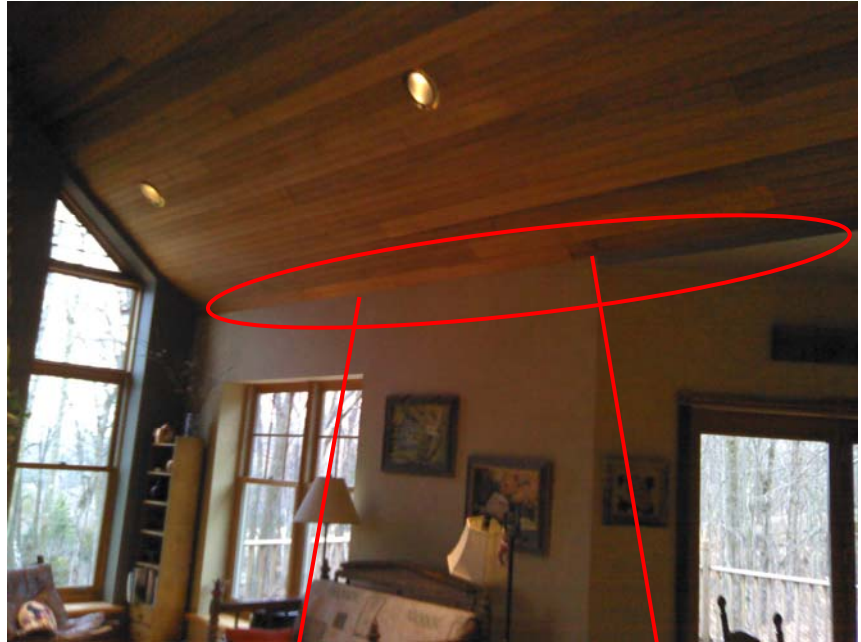
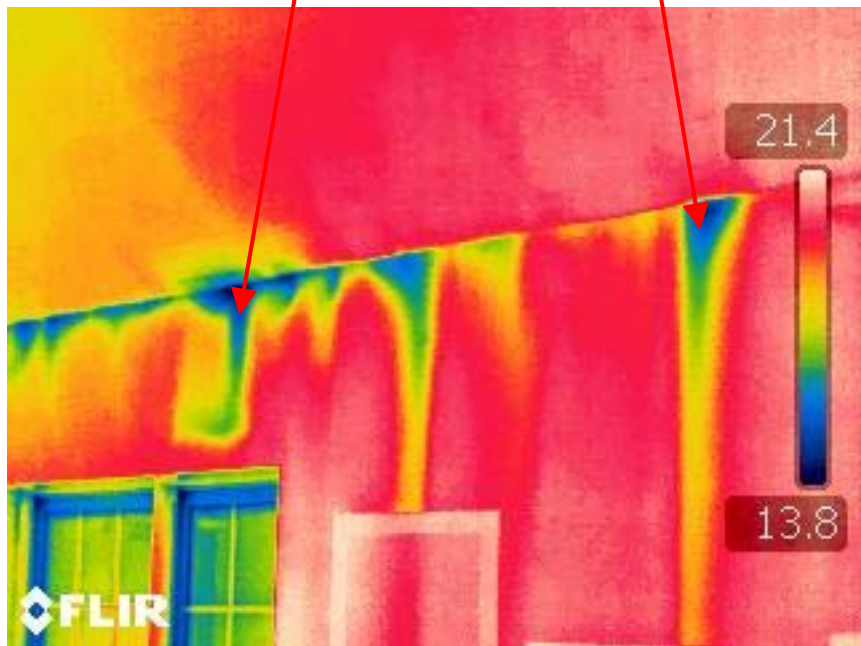
1053 Walls / Veiling

The bleu streaking areas in the picture represent major air leakage.

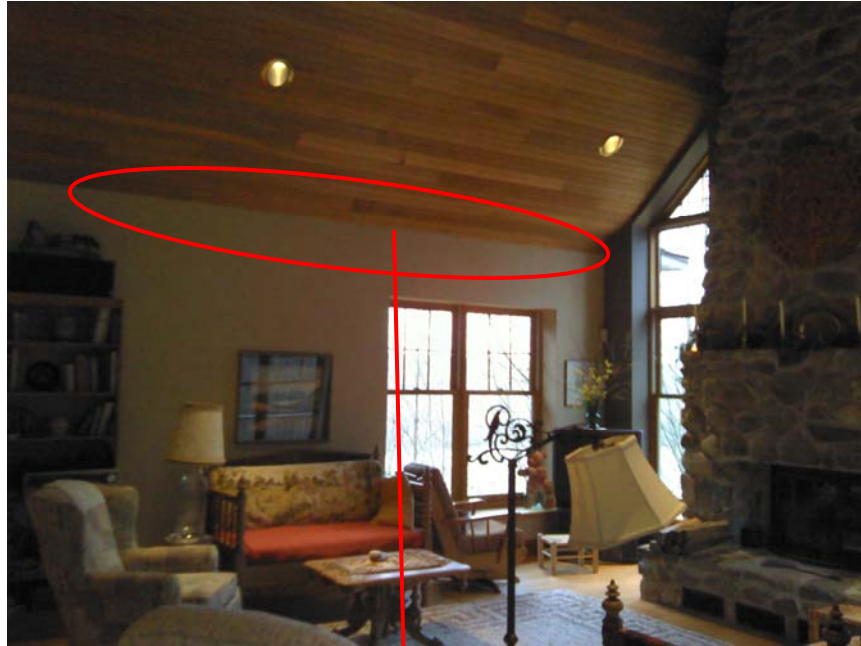
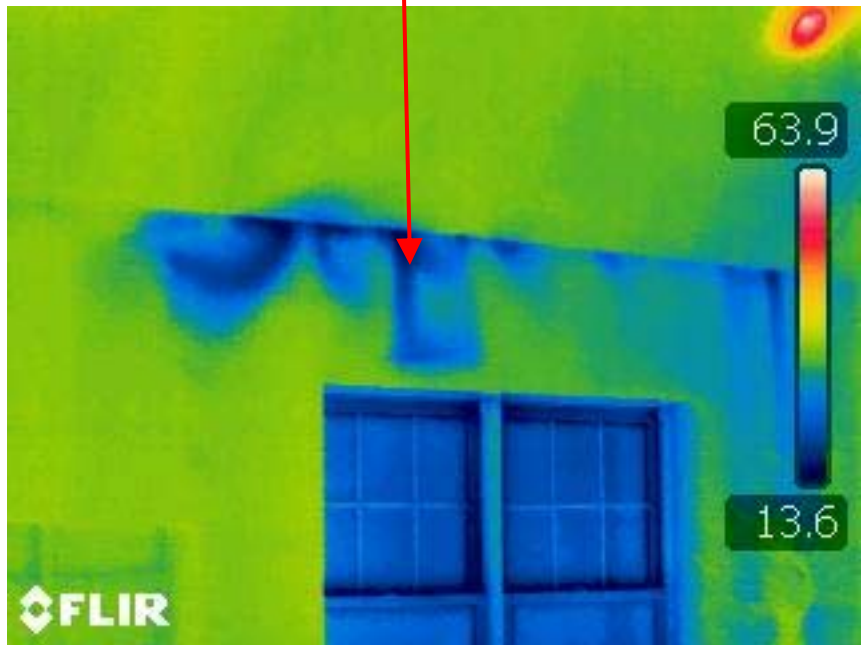
1053 Walls / Veiling

The bleu streaking areas in the picture represent major air leakage.
